**Flood Control Project Maintenance  
Levee Inspections**

**Fall 2019 Levee Maintenance Deficiency Summary Report**

**Sacramento River Basin**

**Sacramento Maintenance Yard Maintenance Area 0009**

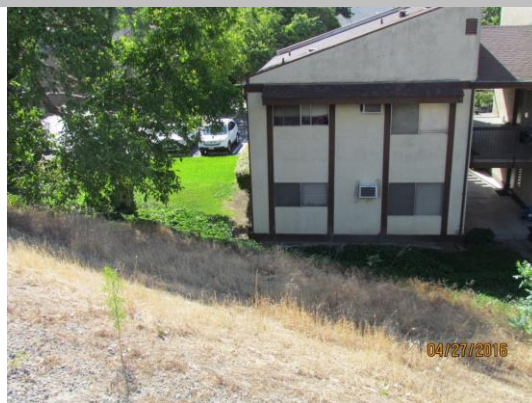
Photo 1 of 1 : FA\_2019\_MA0009\_201\_7\_20190904\_00001.jpg

View of the building on the landward side of the levee. Spring 2016.

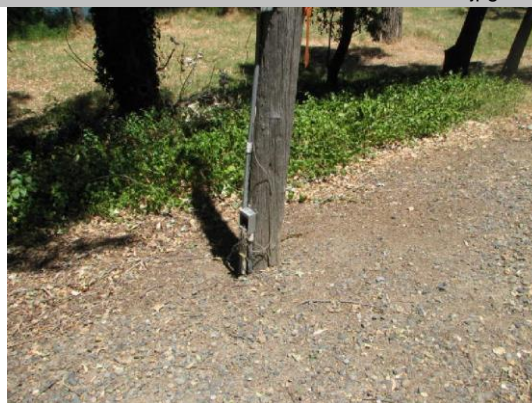
Photo 1 of 2 : UCIP\_FA\_2019\_41534\_6104.jpg

LM Start	0.85	Rating **	M	Issue No.	1772
LM End	0.85	Issue Type +	En	Location *	
Category	Supplemental			GPS Latitude/Longitude	
				Start	End
Item	DRAFT DWR UCIP Field Study			38.532930 °	38.532930 °
				-121.522610 °	-121.522610 °
DWR ID	17407				
Comment Code					
Inspector Comment					
DS_ID:17407 FS_ID:41534 EP_NO: N/A Repair Type: Non-Urgent Crossing Status: Found UCIP Comments: Appears abandoned. FIELD_STRUCT_DESC: 1.5-inch electrical conduit of an unknown material through the levee, at an unknown depth. Pole on the waterside (WS) slope. [Additional Reference(s): DWR Levee Log, 1991]. FS Date: 6/19/2012 7:58:00 AM

Electrical conduit at bottom of pole on water side.

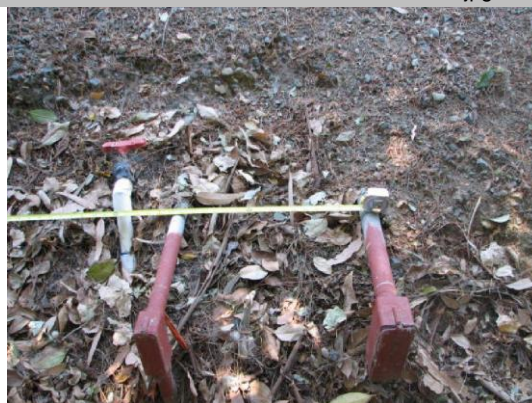
Photo 1 of 3 : UCIP\_FA\_2019\_5843\_8911.jpg

Pipes on LS slope.

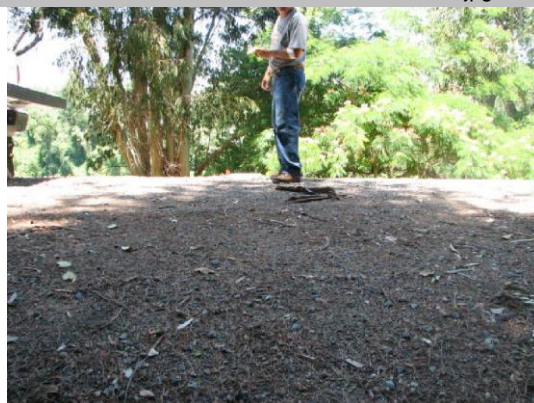
Photo 2 of 3 : UCIP\_FA\_2019\_5843\_8910.jpg

View accross slope towards WS.

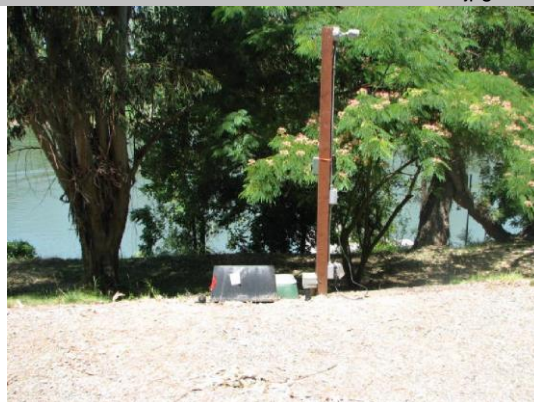
Photo 3 of 3 : UCIP\_FA\_2019\_5843\_8909.jpg

Light on Pole WS slope.

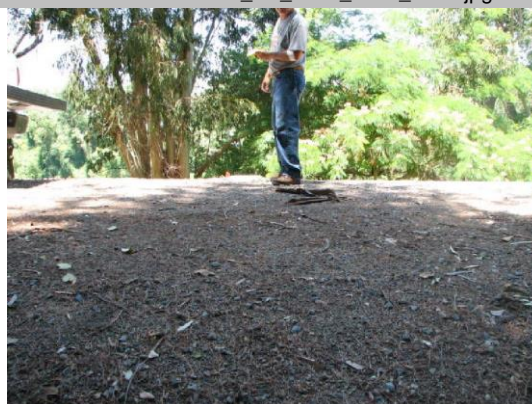
Photo 2 of 3 : UCIP\_FA\_2019\_5844\_8913.jpg

View accross levee towards WS from LS slope.

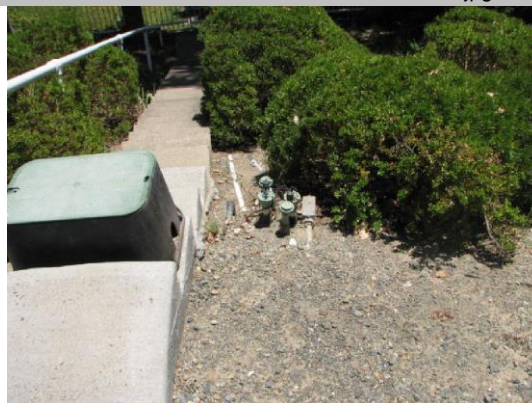
Photo 3 of 3 : UCIP\_FA\_2019\_5848\_8919.jpg

Pipes on LS slope 1-foot downstream from concrete stairs.

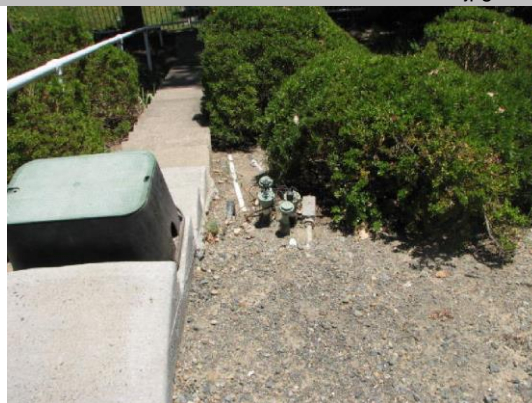
Photo 2 of 2 : UCIP\_FA\_2019\_5849\_8922.jpg

Electrical conduit on LS slope.

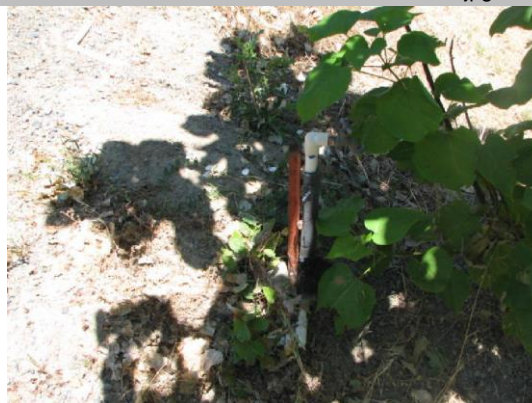
Photo 1 of 3 : UCIP\_FA\_2019\_5850\_8926.jpg

Hose bib and T-post on LS slope 3-feet upstream of concrete stairs.

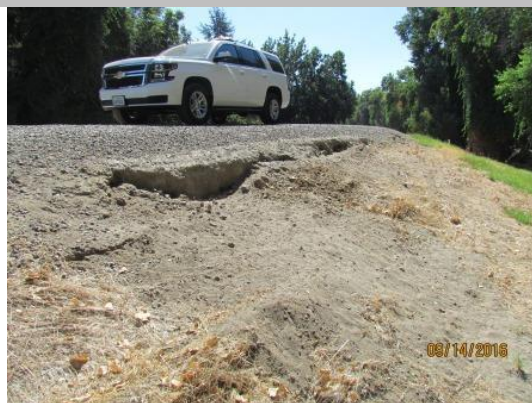
Photo 1 of 2 : FA\_2019\_MA0009\_201\_312\_20190904\_00216.jpg

Erosion site on the waterward side of the levee. Fall 2016 inspection.

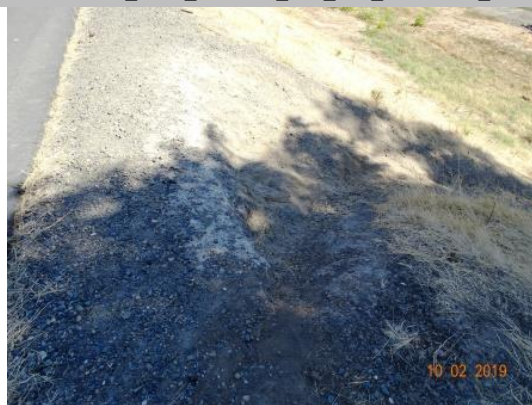
Photo 1 of 1 : FA\_2019\_MA0009\_201\_228\_20191008\_00512.jpg

View of footpath on the landside slope. Fall 2019

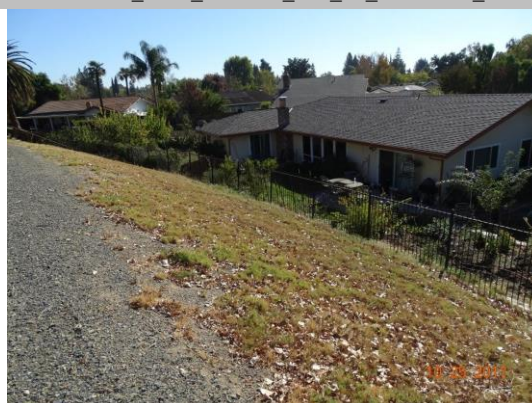
Photo 1 of 1 : FA\_2019\_MA0009\_201\_44\_20190904\_00018.jpg

View of fence at landside toe. Fall 2017.

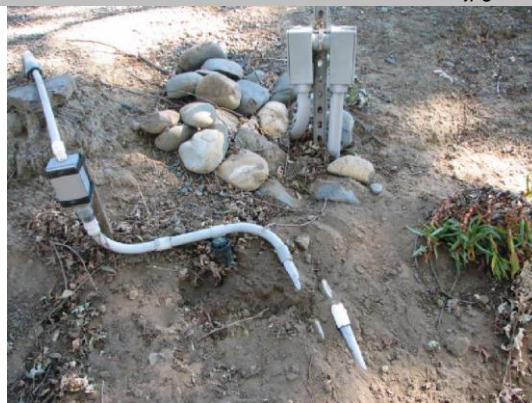
Photo 2 of 2 : UCIP\_FA\_2019\_5860\_8945.jpg

Pipes visible on LS slope approximately 50-feet downstream from pier walkway.

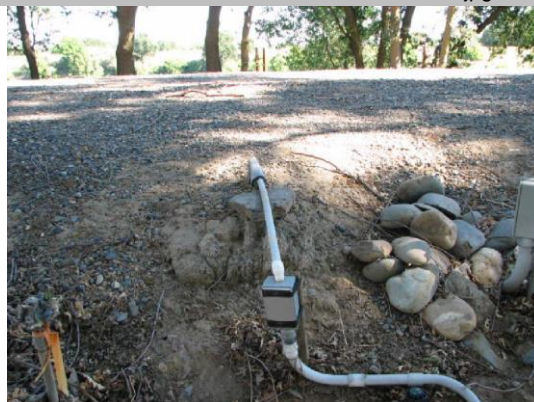
Photo 2 of 2 : UCIP\_FA\_2019\_5856\_8937.jpg

Galvanized steel pipe with pvc electrical conduit running through it, LS shoulder 50-feet downstream from pier/ramp.

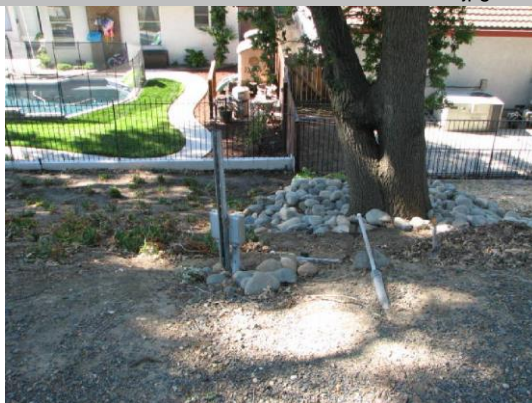
Photo 2 of 2 : UCIP\_FA\_2019\_5854\_8933.jpg

Pipes on LS slope approximately 50-feet downstream from walkway/pier.

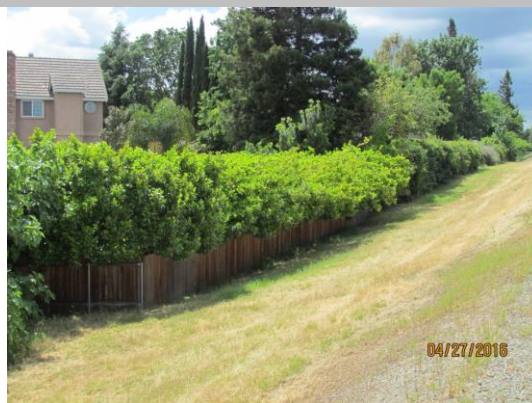
Photo 1 of 1 : FA\_2019\_MA0009\_201\_74\_20190904\_00031.jpg

View of the wooden fence and tall shrubs at the toe of the levee on the landward side of the levee looking downstream. Spring 2016.

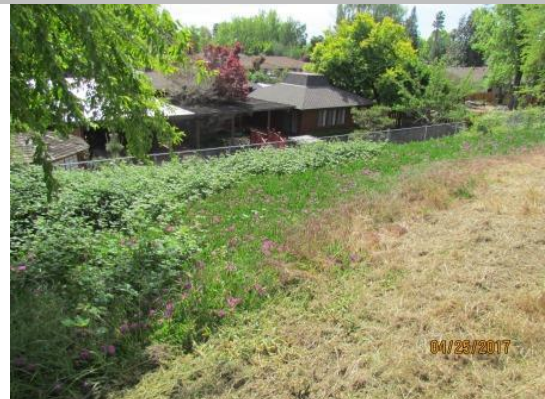
Photo 1 of 1 : FA\_2019\_MA0009\_201\_277\_20190904\_00194.jpg

View of vegetation on landside slope. Spring 2017.

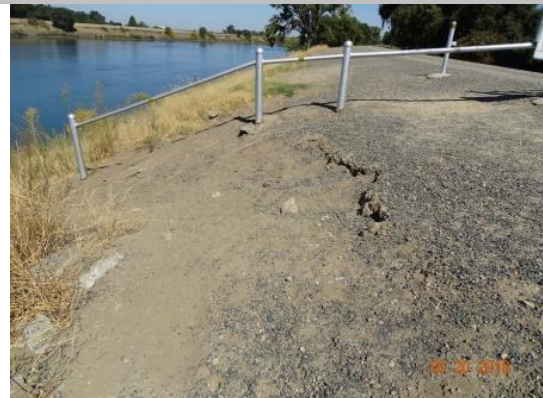
Photo 3 of 3 : FA\_2019\_MA0009\_201\_333\_20190904\_00236.jpg

View of cracking downstream of gate. Fall 2018

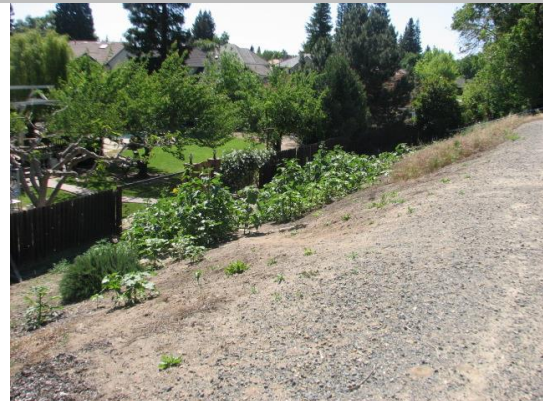
Photo 2 of 2 : FA\_2019\_MA0009\_201\_113\_20190904\_00048.jpg

The garden continues to be on the levee slope. Spring 2014

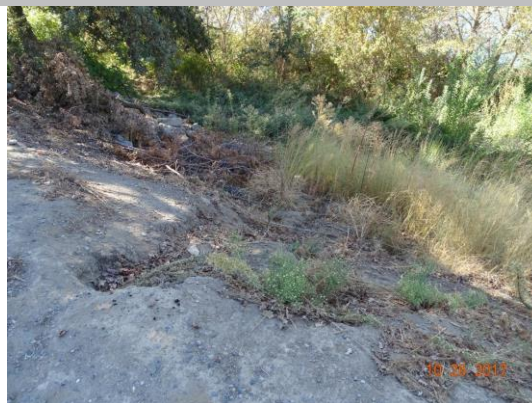
Photo 2 of 2 : FA\_2019\_MA0009\_201\_234\_20190904\_00153.jpg

View of erosion on waterside slope. Fall 2017.

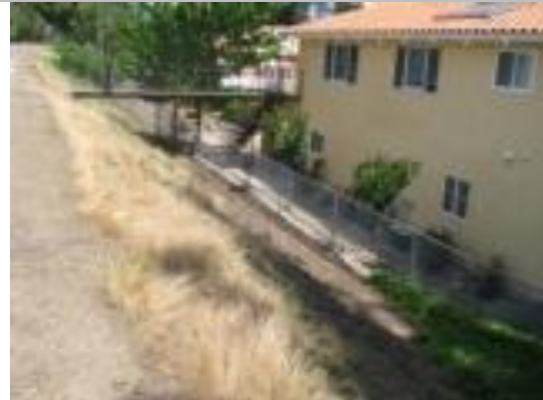
Photo 2 of 2 : FA\_2019\_MA0009\_201\_135\_20190904\_00064.jpg

A retaining wall with a fence on top and some groundcover. Photo taken spring 2012.

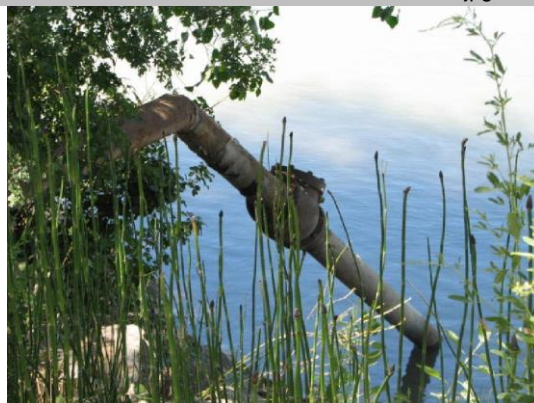
Photo 2 of 3 : UCIP\_FA\_2019\_4980\_6629.jpg

Pipe entering water at WS toe

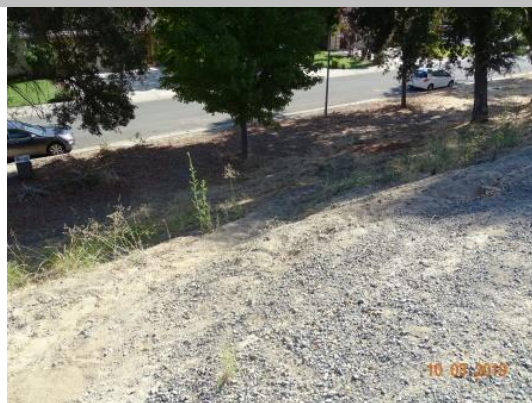
Photo 1 of 1 : FA\_2019\_MA0009\_201\_654\_20191008\_00528.jpg

View of vehicle tracks on the landside slope. Fall 2019

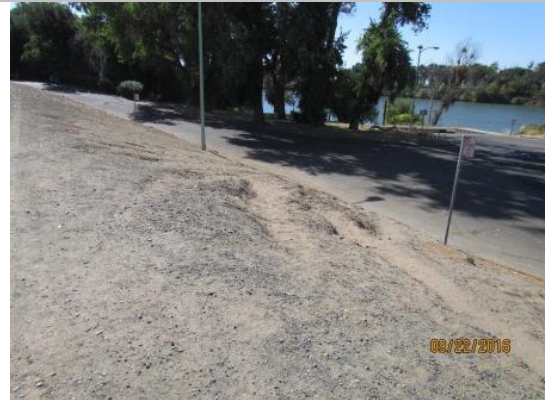
Photo 1 of 2 : FA\_2019\_MA0009\_201\_375\_20190904\_00266.jpg

View of slope stability on WS of the levee. Fall 2016.

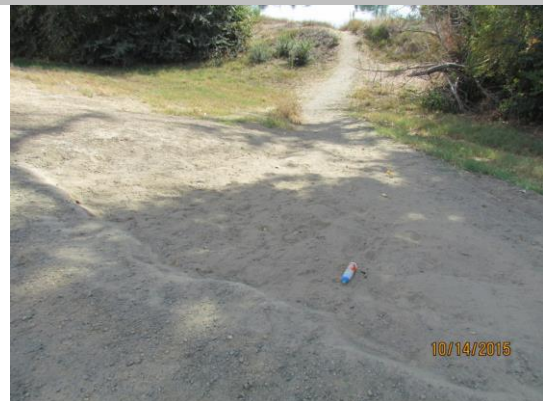
Photo 2 of 3 : FA\_2019\_MA0009\_201\_301\_20190904\_00209.jpg

Looking at the trail caused by foot traffic. Fall 2015.

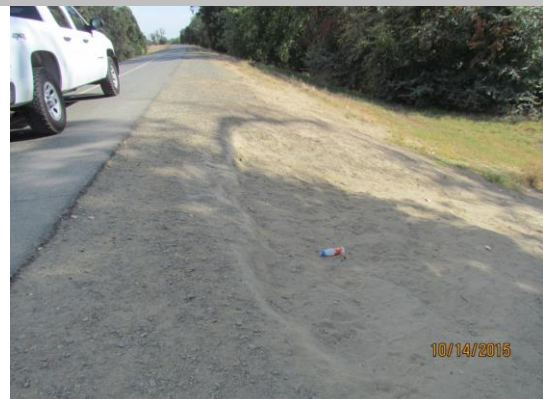
Photo 3 of 3 : FA\_2019\_MA0009\_201\_301\_20190904\_00210.jpg

Perspective view of the slope stability on the waterward side of the levee looking downstream. Fall 2015.

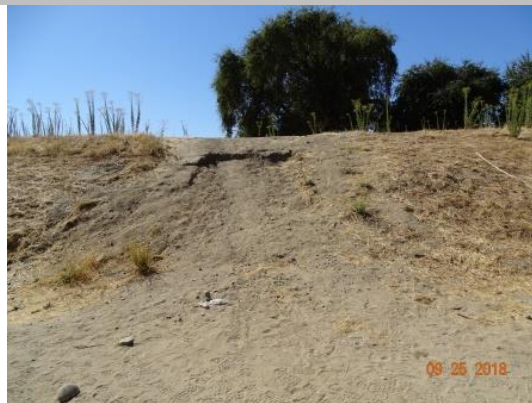
Photo 1 of 1 : FA\_2019\_MA0009\_201\_311\_20190904\_00215.jpg

View of levee slope damaged by foot traffic and possibly by vehicles. Fall 2018

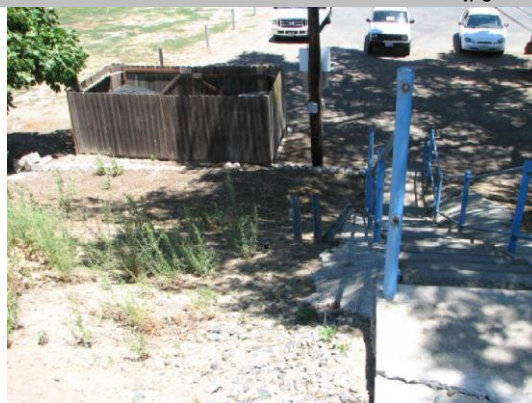
Photo 2 of 2 : UCIP\_FA\_2019\_5904\_8968.jpg

Pipe buried 3-feet upstream from top of stairs on LS slope.

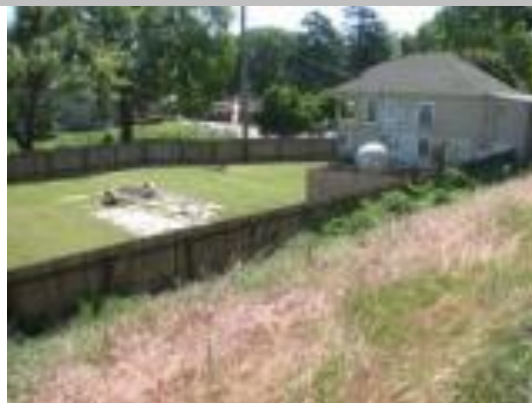
Photo 2 of 2 : FA\_2019\_MA0009\_201\_181\_20190904\_00113.jpg

The fence continues along the toe. Spring 2013

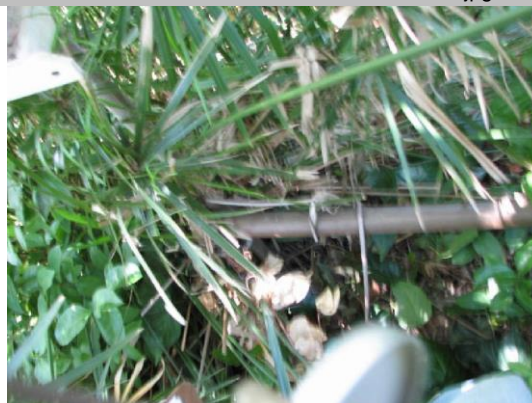
Photo 1 of 3 : UCIP\_FA\_2019\_5908\_8979.jpg

Close up of pipe on WS slope.

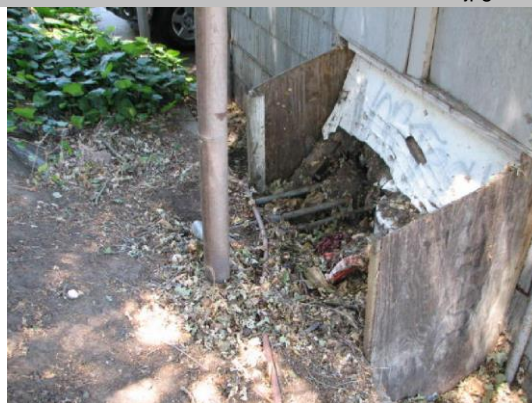
Photo 1 of 1 : UCIP\_FA\_2019\_5110\_6819.jpg

Pipes appear to exit the back of the shed at the LS toe and enter the levee.

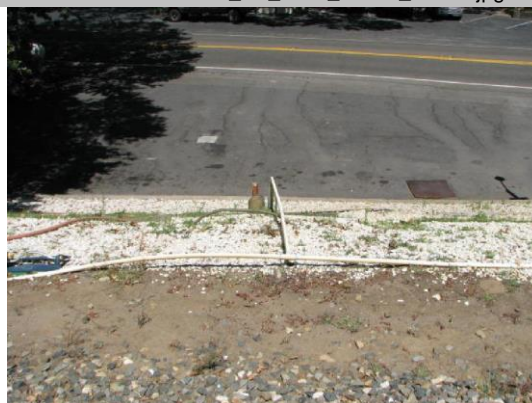
Photo 2 of 3 : UCIP\_FA\_2019\_53470\_20792.jpg

View of PVC pipe running through 2nd pipe.

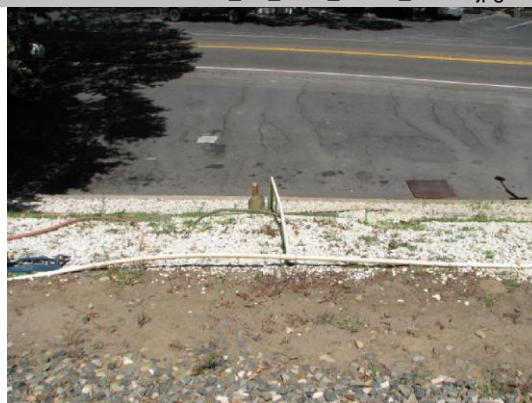
Photo 2 of 3 : UCIP\_FA\_2019\_53471\_20795.jpg

PVC waterline running through pipe on LS slope.

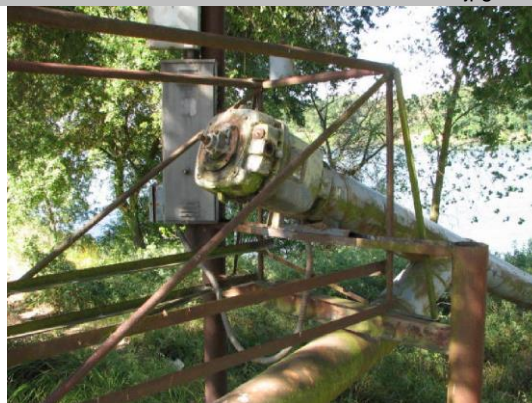
Photo 2 of 3 : UCIP\_FA\_2019\_5117\_6829.jpg

Pump next to meter on pole, WS.

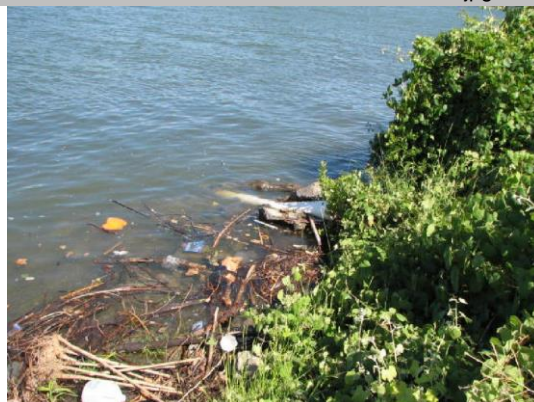
Photo 2 of 2 : UCIP\_FA\_2019\_5920\_9001.jpg

Pipe on WS toe at river.

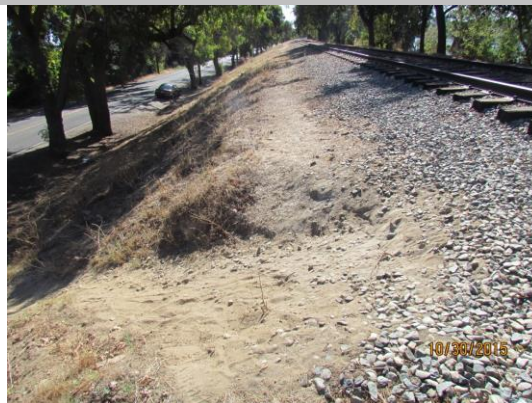
Photo 2 of 2 : FA\_2019\_MA0009\_201\_362\_20190904\_00258.jpg

View of the slope stability on the landward side of the levee looking downstream. Fall 2015.

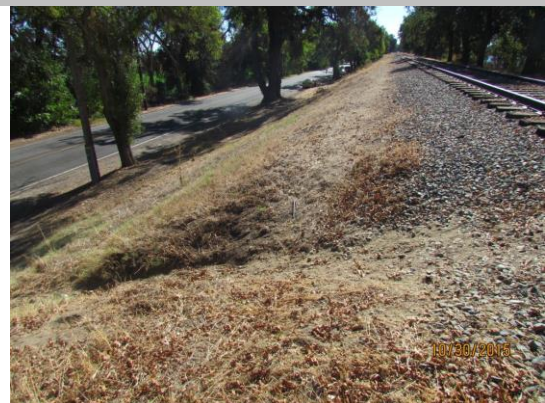
Photo 1 of 1 : FA\_2019\_MA0009\_201\_366\_20190904\_00260.jpg

View of the slope stability on the landward side of the levee looking downstream. Fall 2015.

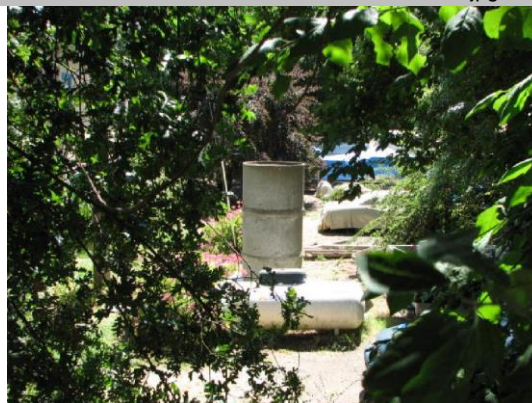
Photo 2 of 3 : UCIP\_FA\_2019\_9443\_16423.jpg

Concrete Standpipe on LS in homeowners yard.

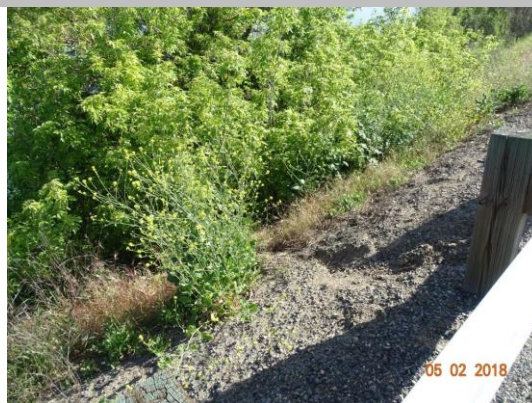
Photo 1 of 1 : FA\_2019\_MA0009\_201\_262\_20190904\_00182.jpg

View of erosion on the waterside slope. Spring 2018.

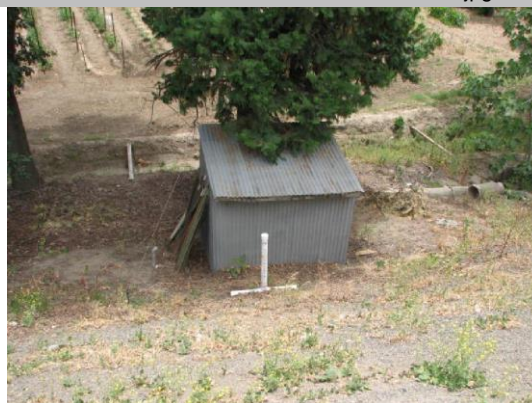
Photo 1 of 3 : UCIP\_FA\_2019\_5133\_6876.jpg

Pumphouse on LS toe.

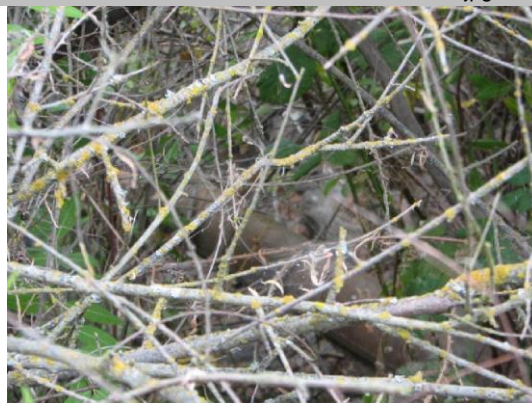
Photo 3 of 3 : UCIP\_FA\_2019\_5133\_6874.jpg

Brush covered pipe on WS slope.

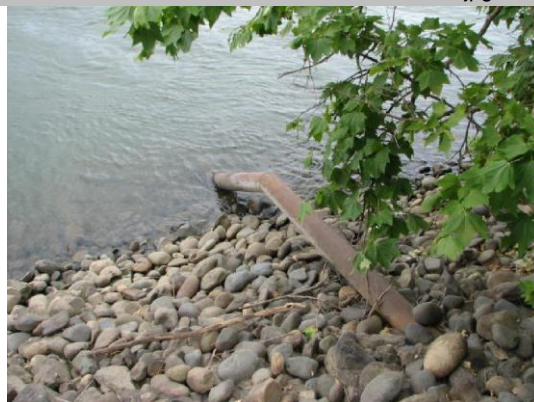
Photo 2 of 3 : UCIP\_FA\_2019\_5139\_6898.jpg

Pipe on WS slope.

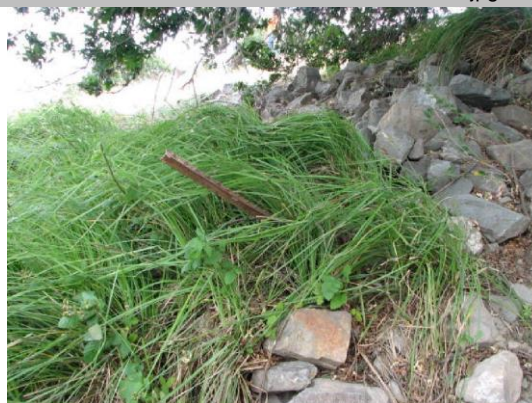
Photo 1 of 2 : UCIP\_FA\_2019\_41065\_6903.jpg

Tpost on WS slope.

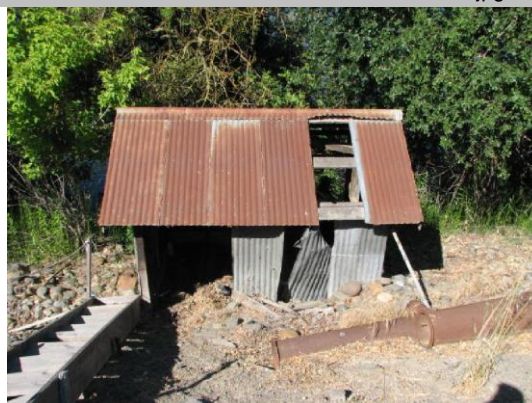
Photo 1 of 3 : UCIP\_FA\_2019\_53474\_20799.jpg

Pumphouse and stairs on WS slope.

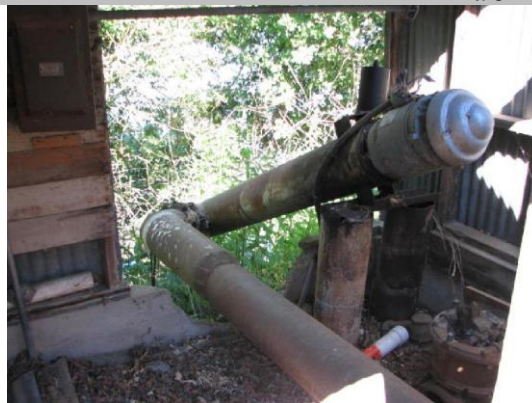
Photo 3 of 3 : UCIP\_FA\_2019\_53474\_20797.jpg

Slant pump in pumphouse.

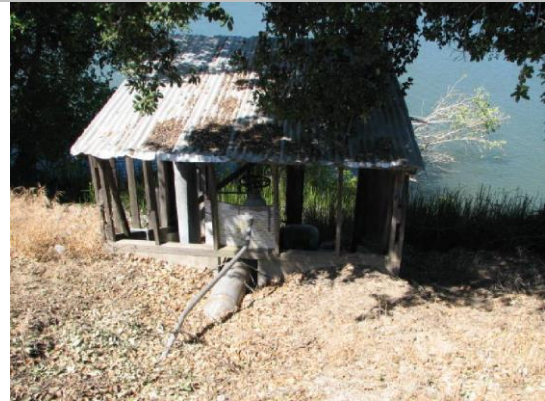
Photo 1 of 3 : UCIP\_FA\_2019\_5172\_6983.jpg

Pump and gate valve in pumphouse on WS slope.

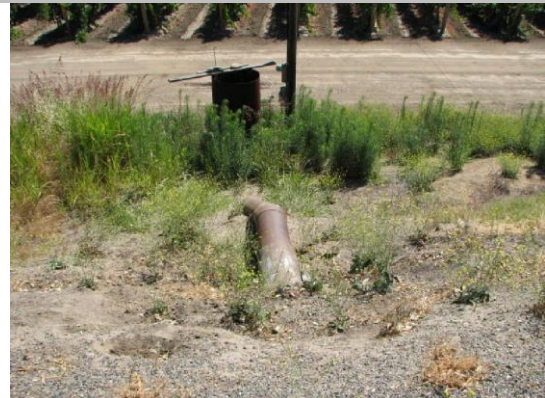
Photo 2 of 3 : UCIP\_FA\_2019\_5172\_6982.jpg

36-inch standpipe, JP, and meter on LS toe.

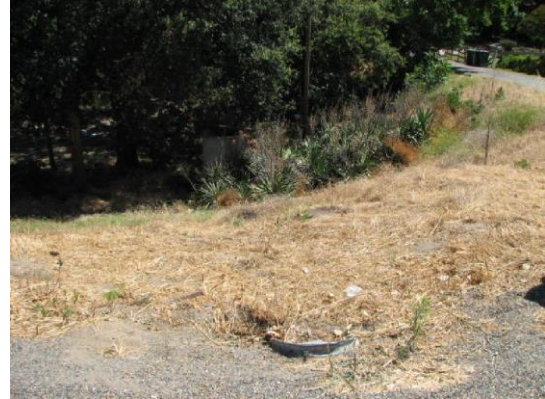
Photo 3 of 3 : UCIP\_FA\_2019\_5174\_6985.jpg

siphon breaker in damaged 24-inch CMP riser on LS shoulder (in foreground)

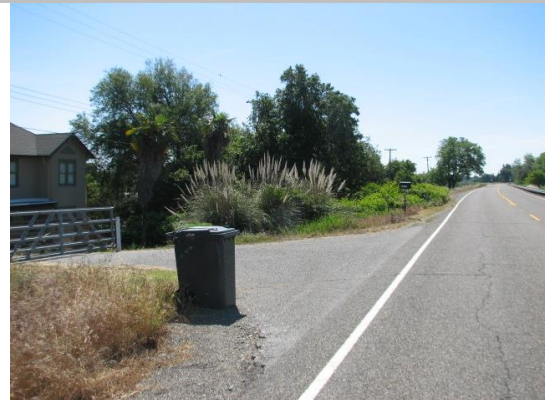
Photo 1 of 2 : FA\_2019\_MA0009\_201\_205\_20190904\_00130.jpg

Looking downstream at the landscaping on the levee slope. Spring 2014

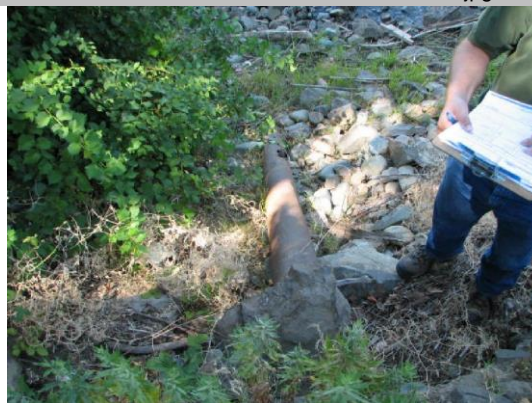
Photo 1 of 1 : UCIP\_FA\_2019\_5175\_6989.jpg

cut-off pipe at WS toe/slope. No indication pipe goes through levee.

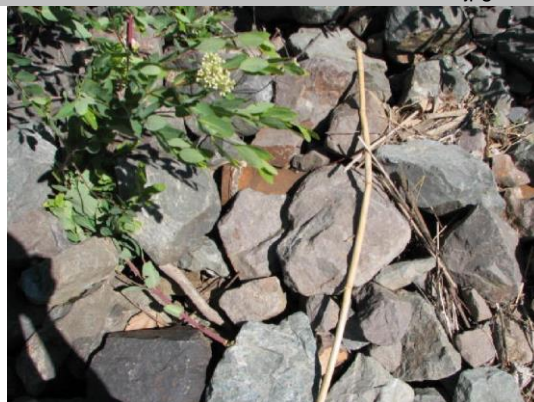
Photo 2 of 2 : UCIP\_FA\_2019\_5926\_9011.jpg

Pipe on WS slope.

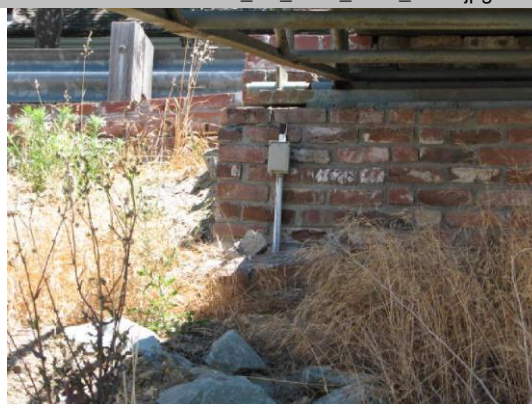
Photo 2 of 2 : UCIP\_FA\_2019\_5928\_9019.jpg

Electrical conduit at WS shoulder on upstream side of pier walkway.

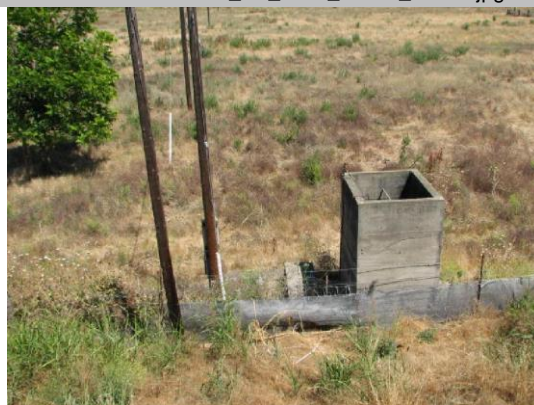
Photo 3 of 3 : UCIP\_FA\_2019\_53478\_20812.jpg

Pipe, JP, meter, and concrete distribution box on LS toe.

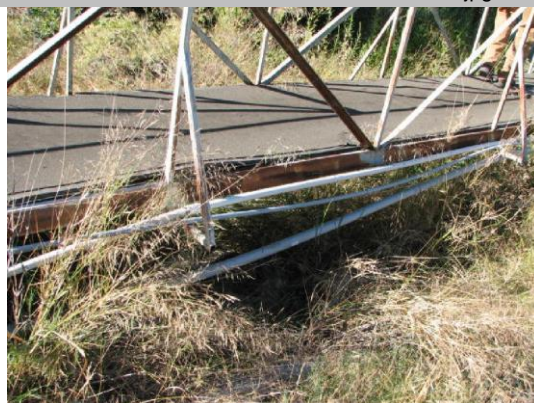
Photo 1 of 2 : UCIP\_FA\_2019\_5929\_9022.jpg

Pipe on upstream side of pier walkway.

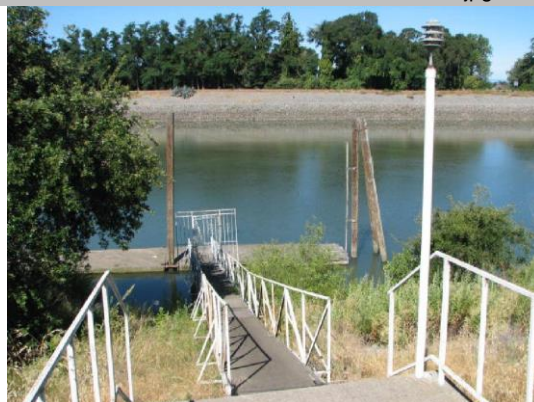
Photo 2 of 2 : UCIP\_FA\_2019\_5929\_9021.jpg

Pier on WS shoulder.

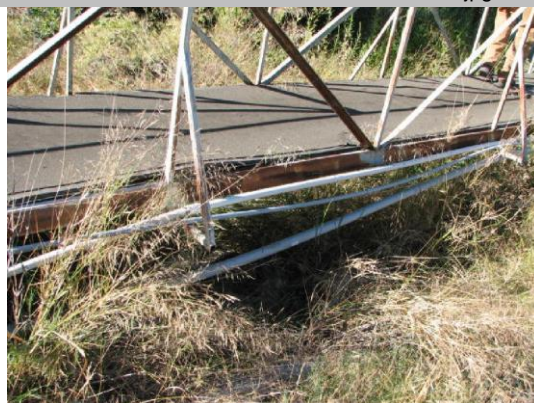
Photo 1 of 2 : UCIP\_FA\_2019\_5930\_9024.jpg

Pipes on upstream side of pier walkway.

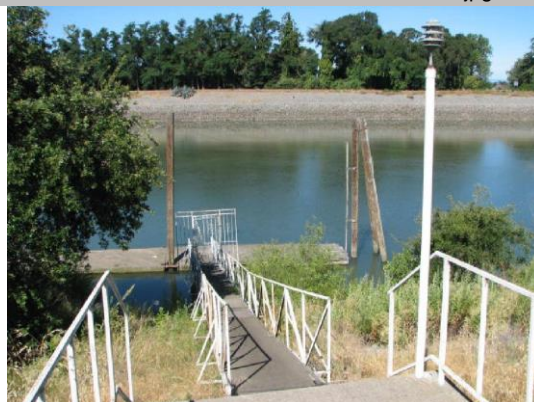
Photo 2 of 2 : UCIP\_FA\_2019\_5930\_9023.jpg

Pier walkway on WS slope.

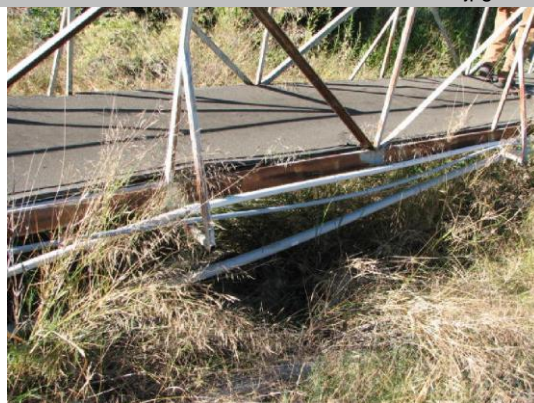
Photo 1 of 2 : UCIP\_FA\_2019\_5945\_9086.jpg

Pipes on upstream side of pier walkway.

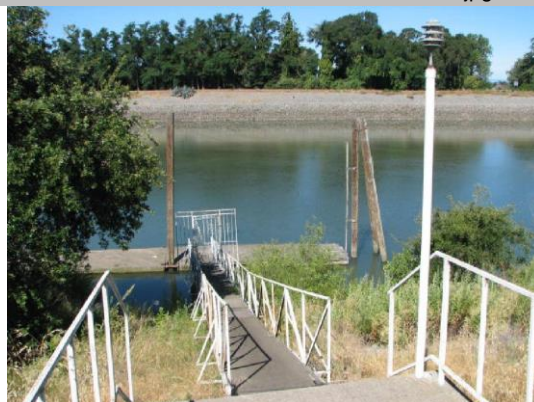
Photo 2 of 2 : UCIP\_FA\_2019\_5945\_9085.jpg

Pier walkway on WS slope.

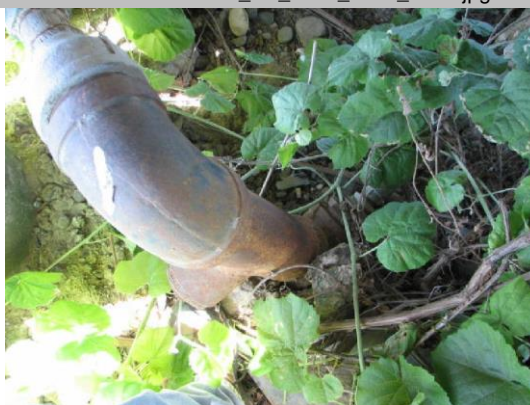
Photo 1 of 3 : UCIP\_FA\_2019\_5933\_9043.jpg

Pipe under walkway of building on WS slope.

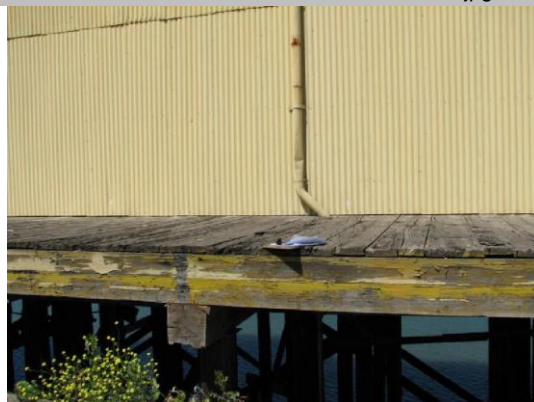
Photo 3 of 3 : UCIP\_FA\_2019\_5933\_9041.jpg

Building at waterside slope.

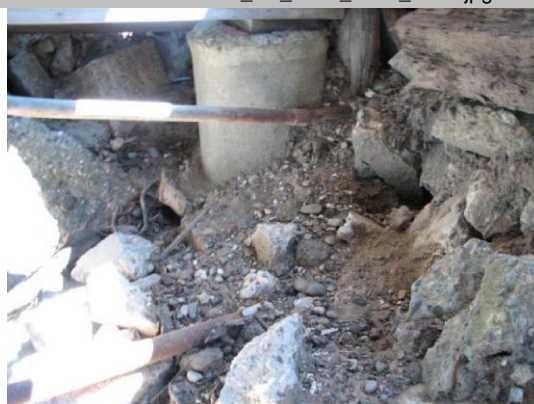
Photo 2 of 2 : UCIP\_FA\_2019\_5934\_9044.jpg

Pipes through levee on WS slope.

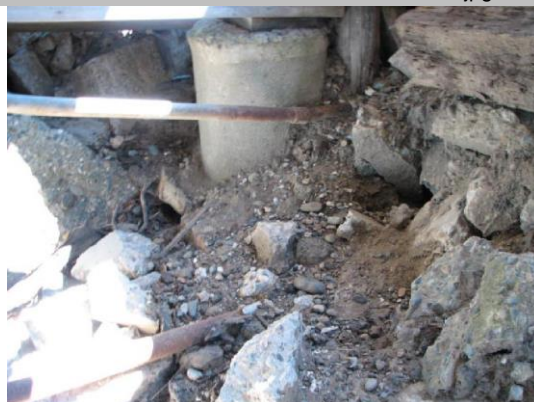
Photo 2 of 2 : UCIP\_FA\_2019\_5935\_9046.jpg

Pipes through levee on WS slope.

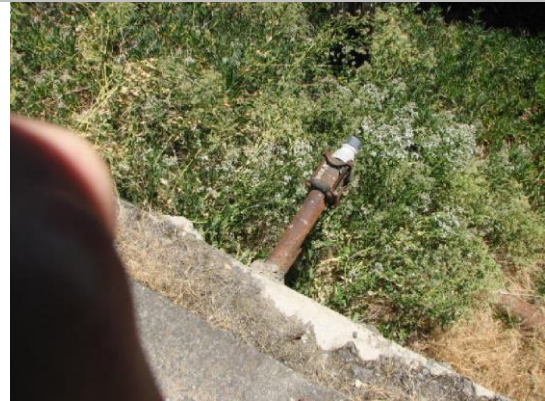
Photo 2 of 2 : UCIP\_FA\_2019\_5937\_9049.jpg

Pipe exiting from concret wall on LS shoulder.

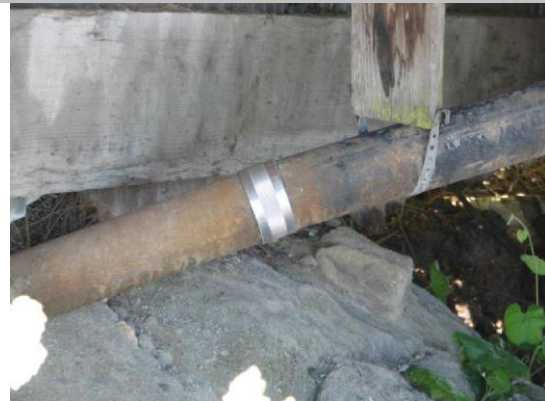
Photo 1 of 2 : UCIP\_FA\_2019\_5938\_9052.jpg

Pipe through levee on WS slope.
